Assessing the technical condition of unfinished or temporarily out-of-service large-panel buildings

ABSTRACT

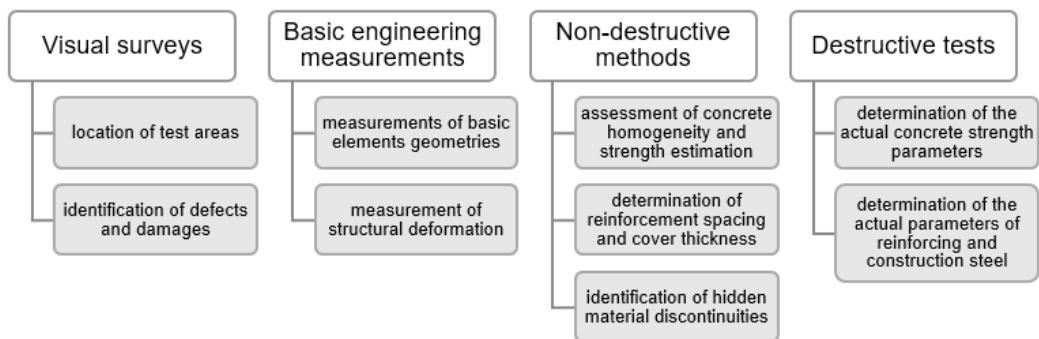
A pilot study of two buildings was carried out. In both, non-destructive tests were carried out with specialised equipment using ultrasound and electromagnetic methods. Locally, the results obtained were confirmed by destructive testing. The test methods used are shown in Figure 1.

Figure 1. Research methods used

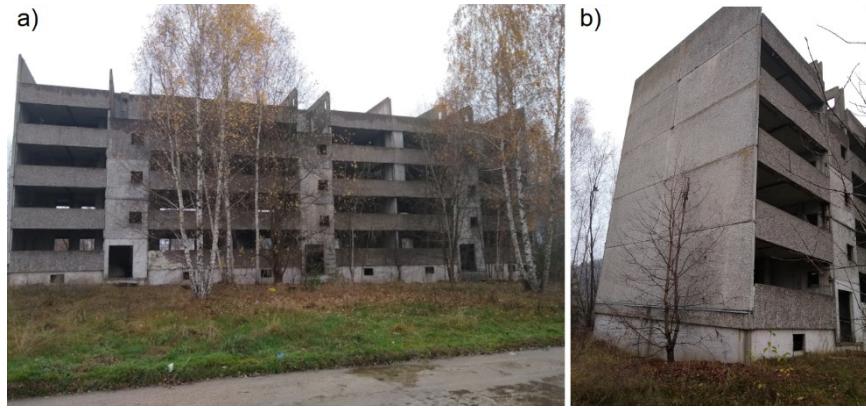
The first analysed building was constructed in large-panel technology in the OWT system in 1980 (Photo 1).

Photo 1. The unfinished building: a) front view; b) curtain wall

The building has five storeys above ground and one underground. The erection of the construction had been interrupted before the roof was completed. The structure was not protected against the aggressive influence of the external environment for more than three decades. Over the course of several years, the technical condition of the building gradually degraded. Structural elements as well as entire buildings required ongoing repair or modernisation [6]. As a consequence of the previous analysis of the results of our own research, damages to large-panel buildings have been identified [7], in the form of typical defects and those resulting from the lack of proper facility management and protection from environmental influences.

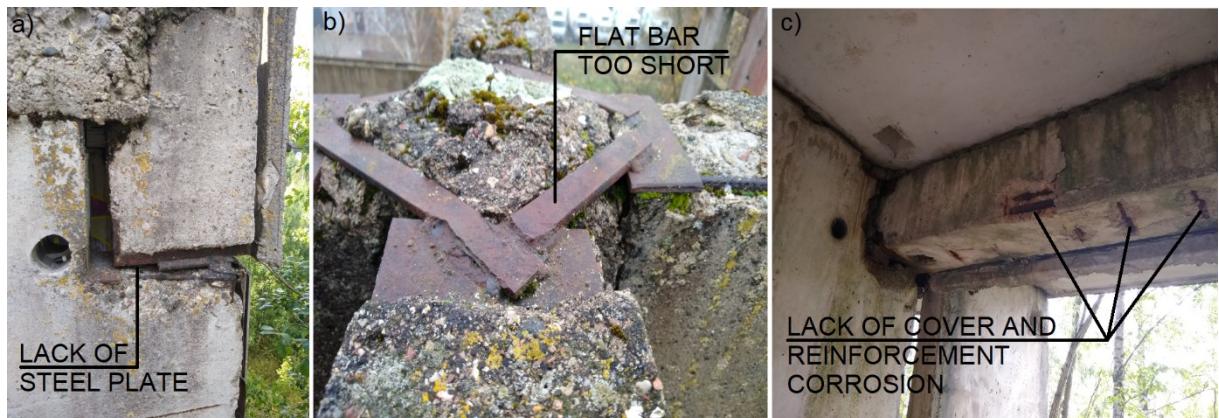
In the first stage of the inspection, visual assessment and basic engineering measurements were carried out to identify defects, improperly made welds, sections, geometric deviations, as well as exceeded assembly tolerances and places of corrosion of concrete and reinforcing steel (Photo 2).

Photo 2. Examples of observed defects: a) lack of plates; b) flat bar and welds too short; c) lack of cover and corrosion of reinforcement

The condition of concrete fillings in horizontal and vertical connections was also analysed. An irregularity that was systematically identified in successive tested elements was the use of flat bars of insufficient length in welded vertical wall joints (Photo 2b). As a result, the welds were too short, which could lead to joint failure. The connections of the beam-walls (external three-layer walls) to the transverse walls were also incorrectly made. In some places the connection plates were missing (Photo 2a), or there were too many pads causing the load-bearing element to tilt. The joint fillings were made carelessly. Numerous delaminations and separations from the precast elements were found in the concrete, as well as large losses in the concrete, resulting in the lack of proper working of the dowel connections. Observed corrosion damage was evident on both exposed rebar and steel connection sections. In order to determine the degree of concrete degradation of the structural elements, non-destructive testing of the walls and floor slabs was carried out using an ultrasound equipment. The principle of operation of the ultrasound method in terms of assessing the homogeneity, discontinuity and strength of concrete has been described in [8]. Limitations and possibilities of verifying the results by combining individual methods have also been published [9]. Scanning of internal walls along selected measurement lines was performed, determining the velocity and propagation time of the longitudinal ultrasound wave (P-wave) in the partition with transducers of 54 kHz frequency, using two-sided access to the elements.

In the case of assessing the technical condition of decommissioned or unfinished structures, it was recommended to: carry out a visual inspection of the structure and initially locate defects; assess the homogeneity of precast concrete comparatively using two methods, i.e. sclerometric and ultrasound; perform B-scans of vertical joints to identify potential material discontinuities; use electromagnetic testing to assess the quality of reinforcement work and locate areas for sampling rebar; perform a limited number of destructive tests to confirm the results obtained by non-destructive methods.

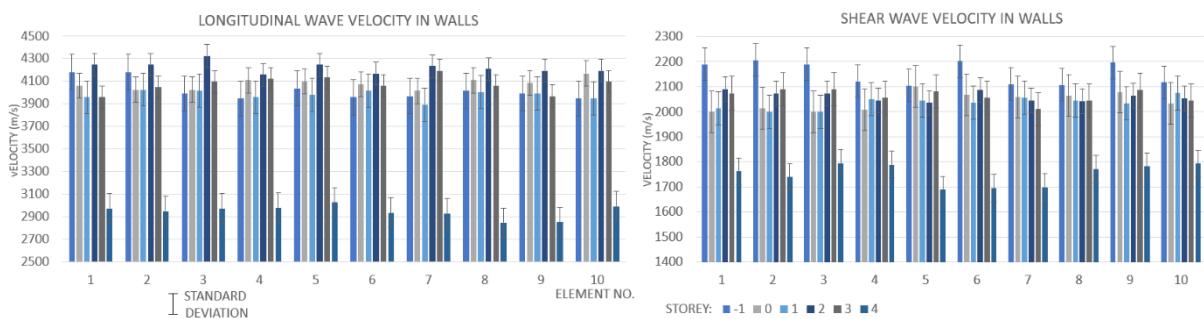
In order to compare the results, measurements were taken at the same points on the internal walls using a head, which is a transverse wave source (S-wave) that does not require two-way access to the test object (Figure 2). Each point in Figure 2 is the average of six readings taken on a given wall. A total of 10 walls on each storey were tested.

Figure 2. Diagram of the velocity of wave propagation in reinforced concrete walls depending on the concrete condition on a given storey: a) longitudinal wave; b) transverse wave

In [10] methods were given to assess the quality of concrete based on the velocity of ultrasound wave propagation. In the case of storeys -1 to 3, the longitudinal ultrasound wave

makes it possible to classify the concrete into the "good" category, while on the last storey into the "weak" category. In the walls of storeys -1 to 3, the shear (transverse) wave velocity ranges from 2000 - 2300 m/s and is defined as typical for concrete. The results of the concrete quality test, carried out using longitudinal and transverse waves, appeared to coincide. They indicated a significant degradation of the walls of the top storey, resulting from corrosion processes.

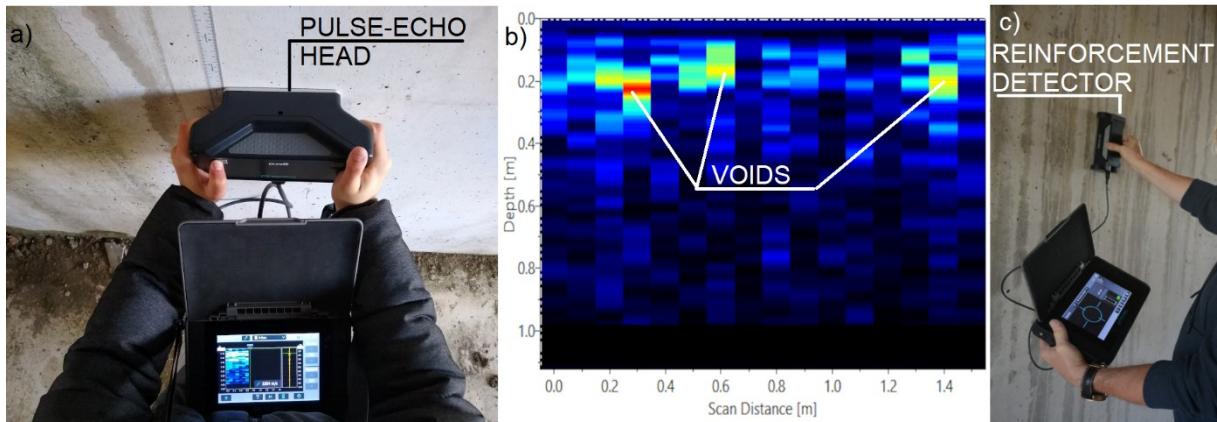
In order to identify material discontinuities, B-scans of selected walls and vertical joints were performed (Photo 3a) using a Pulse-Echo head. The B-scan generates a cross-sectional image of the component under investigation, perpendicular to the scanned surface. Defects and discontinuities are colour coded from turquoise to red. No significant irregularities were detected in the walls. Numerous material discontinuities were found in the joints (Photo 3b), which could be the result of the separation of concrete fillings from the surface of the prefabricated elements, or of their careless filling, which results in improper joint working.

In the next step, an electromagnetic test of the reinforcement distribution and the thickness of the cover were carried out (Photo 3c).

Photo 3. Non-destructive testing: a) B-scan performance; b) fill scan result; c) electromagnetic testing

In all investigated structural elements the thickness of the cover was insufficient. The strong carbonisation of the concrete caused the cover to become detached. Reinforcing bars were visible in some places. They were heavily corroded and showed local section losses of up to 0.4 mm. The reinforcement distribution was mostly in line with the archival design and the system solutions.

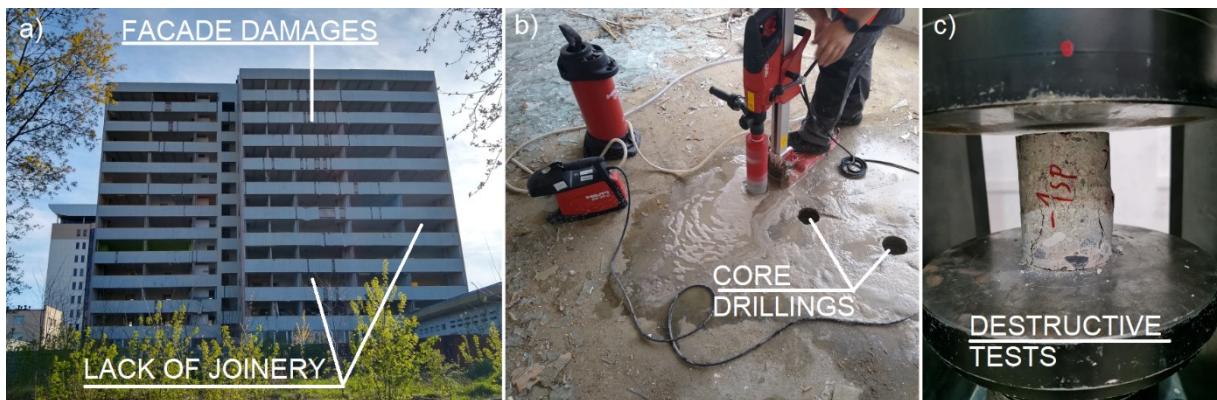
The second building analysed was the OWT-67 large-panel office building, with eleven storeys above-ground and one underground (Photo 4a).

Photo 4. Out-of-service building: a) front elevation; b) core drilling; c) destructive testing

It was constructed in 1978 and decommissioned in 2011, followed by the removal of the window frames. For over 10 years the building was unheated, unprotected from the weather conditions and exposed to vandalism. Visual examinations revealed corrosion of the reinforcing bars of the beam-walls, which had been exposed during the inadequate dismantling of the window sills. On the outside, damage to the sheet metal forming the facade of the office building was located. The defects were caused by furnishings being thrown

The walls and floor slabs were tested using ultrasound, sclerometric and destructive methods (Photo 4b and c). The results of all tests were convergent and allowed unequivocally to classify the concrete as C16/20 (formerly B20). The concrete was characterised by a homogeneous structure despite the fact that more than a decade the building was without supervision, heating or external joinery.
