# Laser scanning as a source of information in the analysis of the facades of heritage at risk – the mansion in Kliczewo Male

## *Skanowanie laserowe jako źródło informacji w analizie elewacji zagrożonego obiektu zabytkowego – dworu w Kliczewie Małym*

DOI: 10.15199/33.2022.08.12

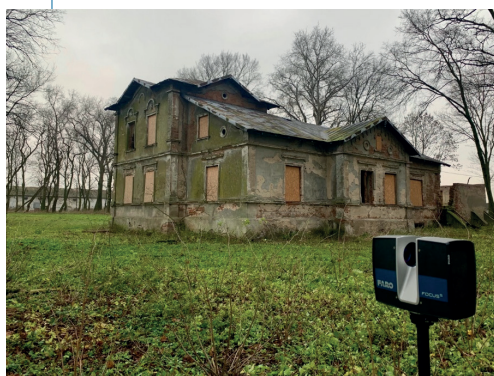
**Photo 1. Mansion in Kliczewo Małe with a Faro laser scanner in the front**  
*Fot. 1. Dwór w Kliczewie Małym ze skanerem laserowym Faro na pierwszym planie*

The building was scanned in November 2021 with the FARO Focus S70 laser scanner [2] (Photo 1), which enables measurements to be made with an accuracy of 1 mm. The weather conditions did not negatively affect the obtained point clouds. The scan was performed with one device from 19 positions in 3 hours and covered only the exterior of the building. A scan of the interior ele-

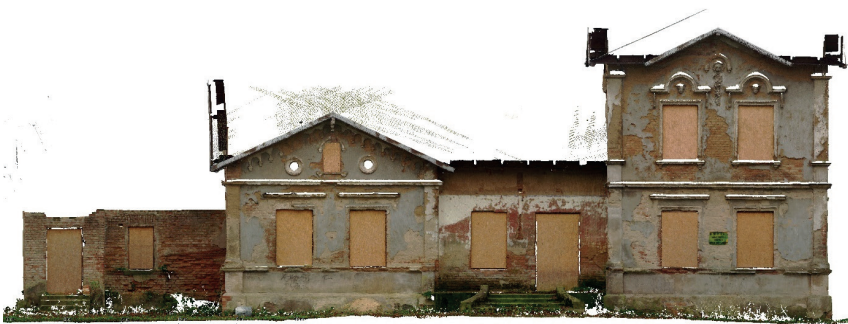
**Photo 2. View with RGB information of the front elevation of the manor house in Kliczewo Małe**

The point cloud is the starting material for analysing the elevation of the manor house in Kliczewo Małe presented in the article. In the discussed example, the documentation consists of elevation views with RGB information (Photo 2), Reflectivity map, Delta map and MESH geometry representing the selected detail. The basic form of the study is a flat drawing of the elevations. It is presented in a form similar to a photograph and eliminates the distortion of the perspective. With classical work methods, the point of error will always be higher than in laser scanning. A good example is tape measurements done by hand or profile creation out of specific wire – this might always be an assumption to some extent. The only human error that can happen with laser scanning is during registration. However, it can be fixed later during the registration process and does not in-

involve remeasuring structure – which in the worst-case scenario can be already destroyed by the time the next survey is performed or could be altered. Measured data also contains RGB information, on the basis of which it is possible to estimate the finishing materials and their colours shown in the Photo 2. Details, dirt, cavities and blooms are also visible. This study can be the basis for further detailed analysis developed in the form of drawing views with marked height information, dimensions and descriptions.

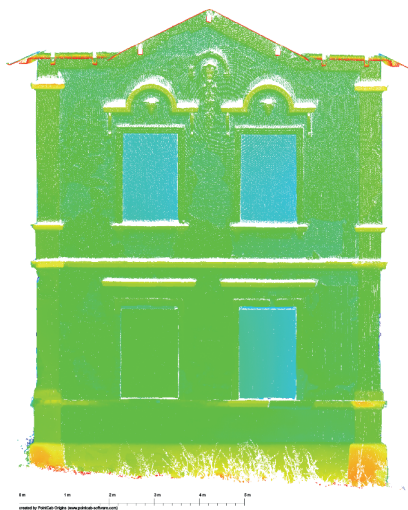
**Photo 4. Delta map of a fragment of the front elevation of a mansion in Kliczewo Małe**

related to its protection. In this type of map, the tectonics of the elevation and the location of pilasters, cornices and bas-reliefs are visible (Photo 4).
